STUDY OF INTERGRANULAR CORROSION ON NON-HEAT TREATABLE ALUMINUM ALLOYS IN A COMPRESSOR AFTER-COOLER

Dewa Nyoman Adnyana

Program Studi Teknik Mesin, Fakultas Teknologi Industri
Institut Sains dan Teknologi Nasional, Jakarta Selatan 12640

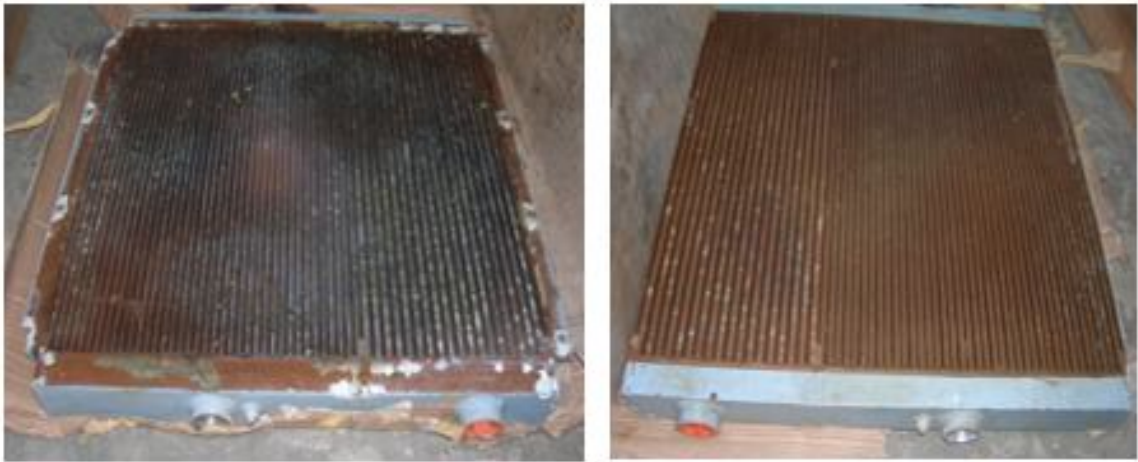
The present work aims to study damage mechanism that has frequently caused a compressor after-cooler to leak. Figure 1 shows a leaked compressor after-cooler that was used for the present study. The after-cooler was equipped with two separated or independent pressure chambers, namely compressor air cooler and compressor lubricating oil cooler. As indicated in Figure 1, the leak is located at the oil cooler around the corroded area on the weld joint between the inlet header and the side bar/parting sheet.

Figure 1. The as received failed compressor after-cooler that was used for the present study

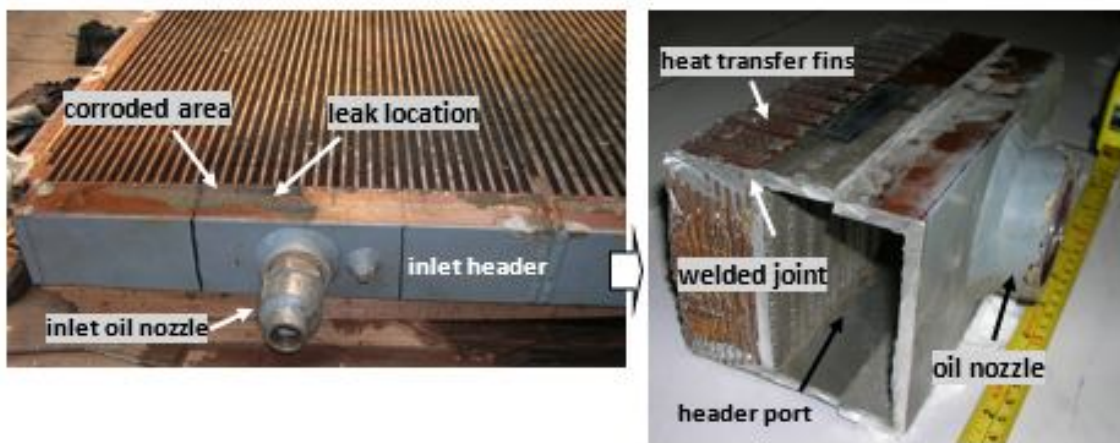
Figure 2. Cutting-off the failed after-cooler around the leak location for sample preparation and examination

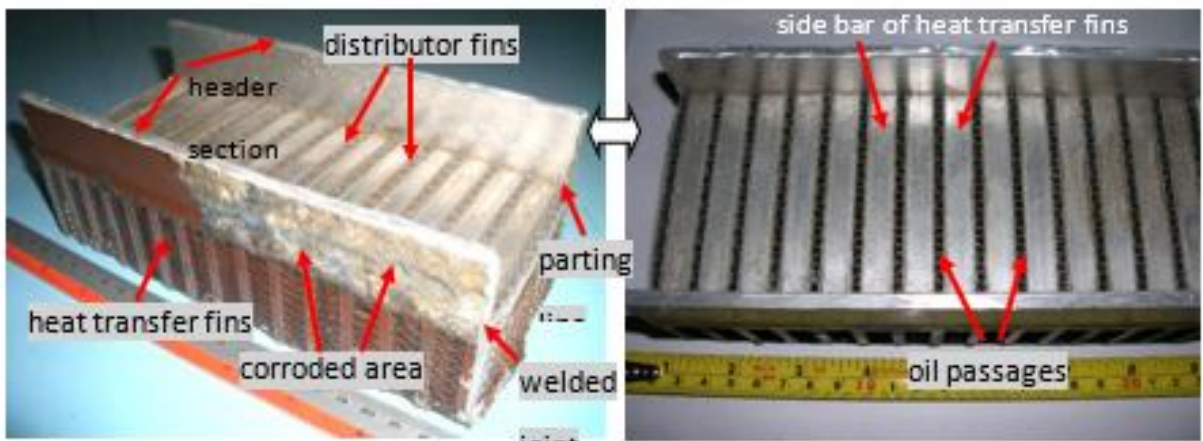
Figure 3. Close up view of the inside header port, showing a number of oil passages containing distributor fins and parting line of the weld joint between header and side bars/parting sheets

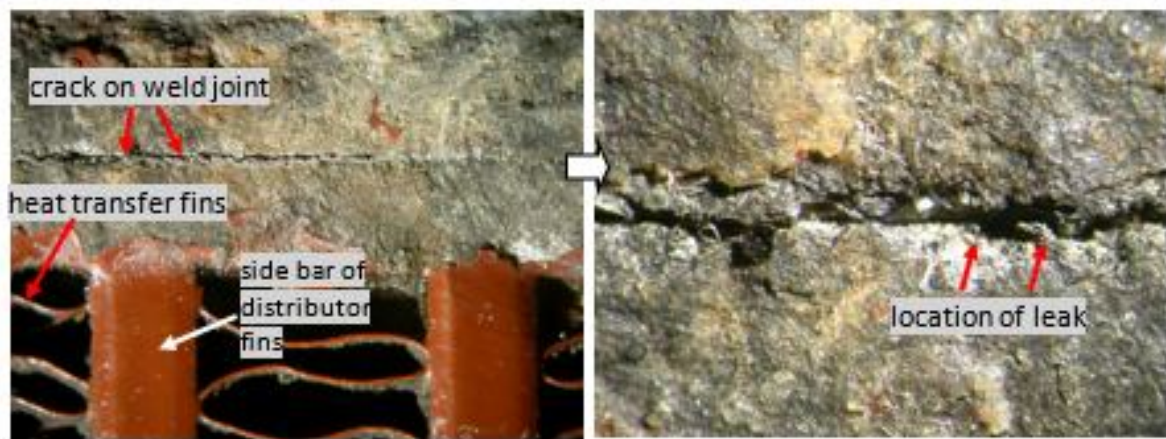
A close up view of the failed after-cooler around the leak location is given in Figure 4. It is seen that the location of oil leak on the after-cooler is a linear crack that formed on the parting line of weld joint between inlet header and side bar/parting sheet.

Figure 4. Close up view of the corroded surface area around the weld joint that caused the after-cooler to leak

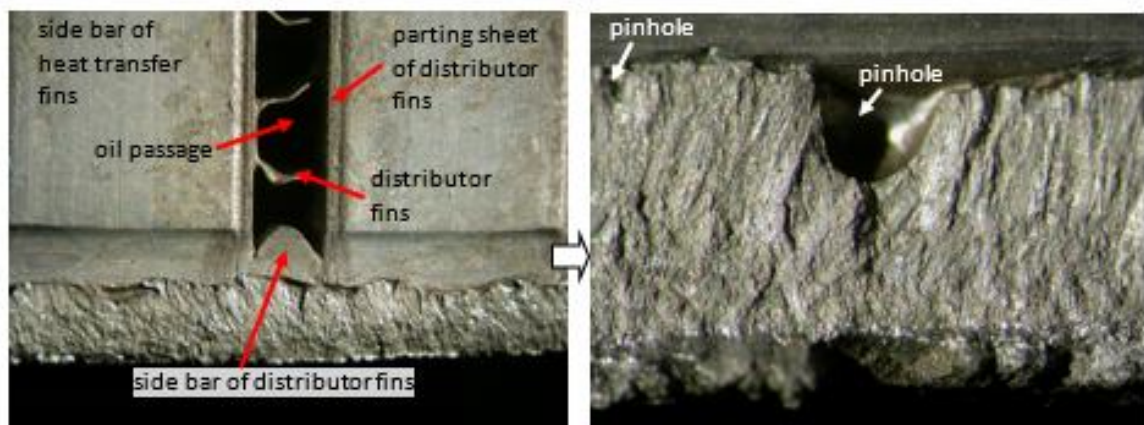
The results of macroscopic examination obtained from some leaked area on the weld joint between the inlet header and the side bar/parting sheet of the compressor after-cooler shown in Figure 4 are presented in Figure 5. It can be seen from Figure 5 that most of the weld surface

fracture apparently contained a number of pinholes due to gas porosity. In addition, some corrosion attack was also indicated to have entered into some surface fracture of the weld. Beside that, the application of one single fillet weld may have further reduced the load-carrying capacity of the weld joint between the inlet header and the side bar/parting sheet and therefore it was prone to cracking.

Figure 5. Surface fracture of the weld joint between header and side bar/parting sheet

In addition to external corrosion and weld defect, the premature failure of the after-cooler was also likely caused by insufficient weld design as the weld joint between the header and the side bar/parting sheet of the after-cooler only used a single fillet weld. The application of another fillet weld on the inside parting line between header and side bar/parting sheet may improve the load carrying capacity of the weld joint structure, and hence it may increase the operating life of the after-cooler significantly.

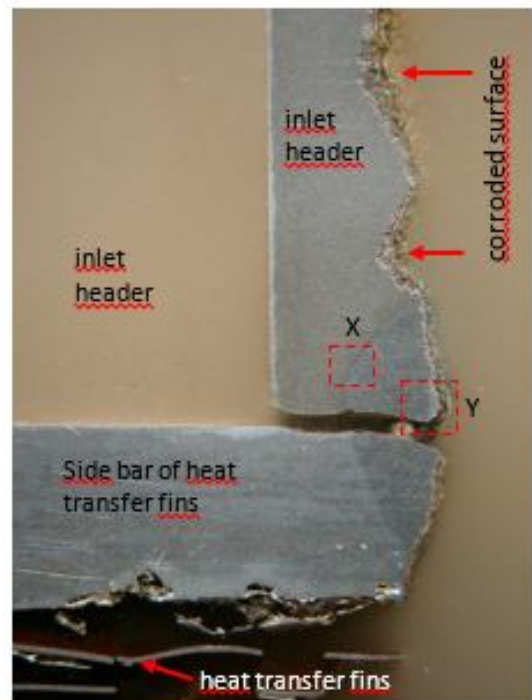
Figure 6 shows a cross-section of a polished and etched specimen obtained from the leaked weld joint between the

inlet header and the side bar of the after-cooler/oil cooler. The specimen shows a fracture line lied along the parting line between the header and the side bar of heat transfer fins. The fracture may have been

Figure 6. Cross section of a polished and etched specimen obtained from the leaked weld joint between header and side bar/parting sheet

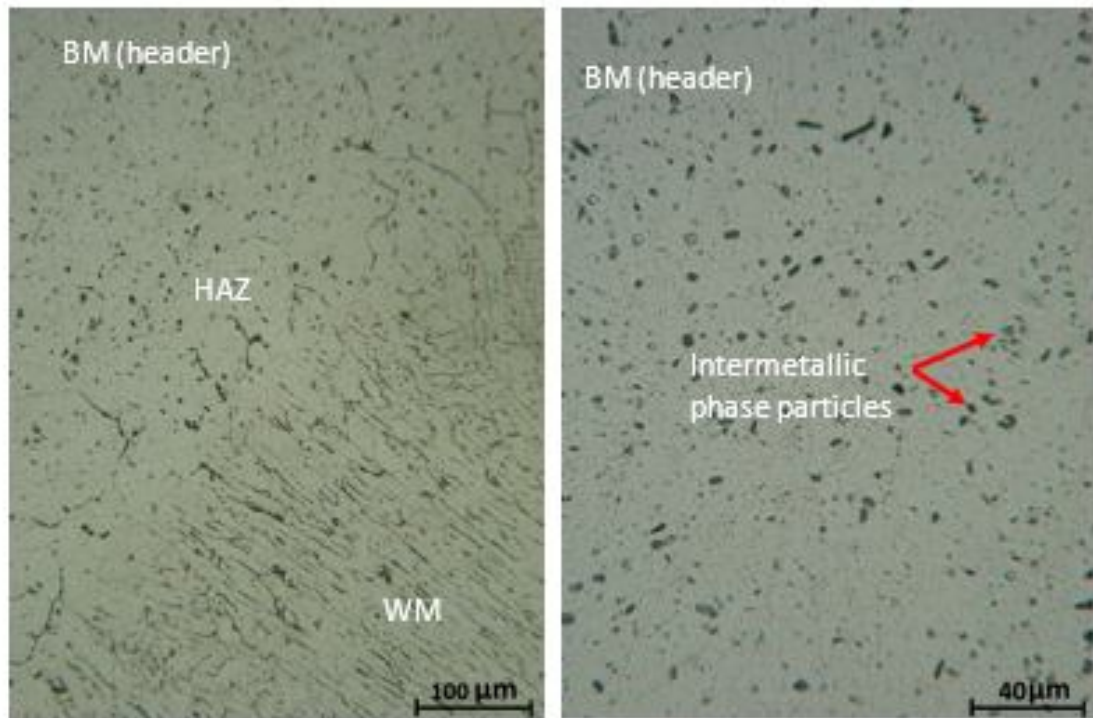
originated from the heavily corroded weld surface. Microstructure obtained from the specimen shown in Figure 6 are presented in Figure 7 at different locations. In the weld joint of the header side shown in Figure 7a, the microstructures obtained are located around the weld metal (WM), heat affected zone (HAZ) and around the base metal (BM). The microstructure of weld metal generally shows a dendritic type, while the microstructure of the header material at its base metal shows typical wrought aluminum alloy microstructure containing fine intermetallic second phase particles [1,2,8-10]. Similar to the macrostructure shown in Figure 5, the microstructure obtained from the weld metal also apparently exhibits a number of large pinholes (see Figure 7b). This further confirms that the fillet weld between the inlet header and the side bar/parting sheet of the compressor after-cooler contained some amount of weld defect. In addition, the microstructures shown in Figure 7b also exhibit some area with heavy damage of external corrosion. The corrosion damage on the weld metal surface in general shows typical interdendritic corrosion. This interdendritic corrosion may have been caused by sensitization that occurred on the weld metal due to formation of a number of intermetallic phases during welding process or in service at extended high temperature exposure [1, 2, 8, 10].

Figure 7a. Microstructure obtained from the weld joint between header and side bar/parting sheet at location X as indicated in Figure 6 (etched with Keller solution). Note BM is base metal, HAZ is heat-affected zone, and WM is weld metal.

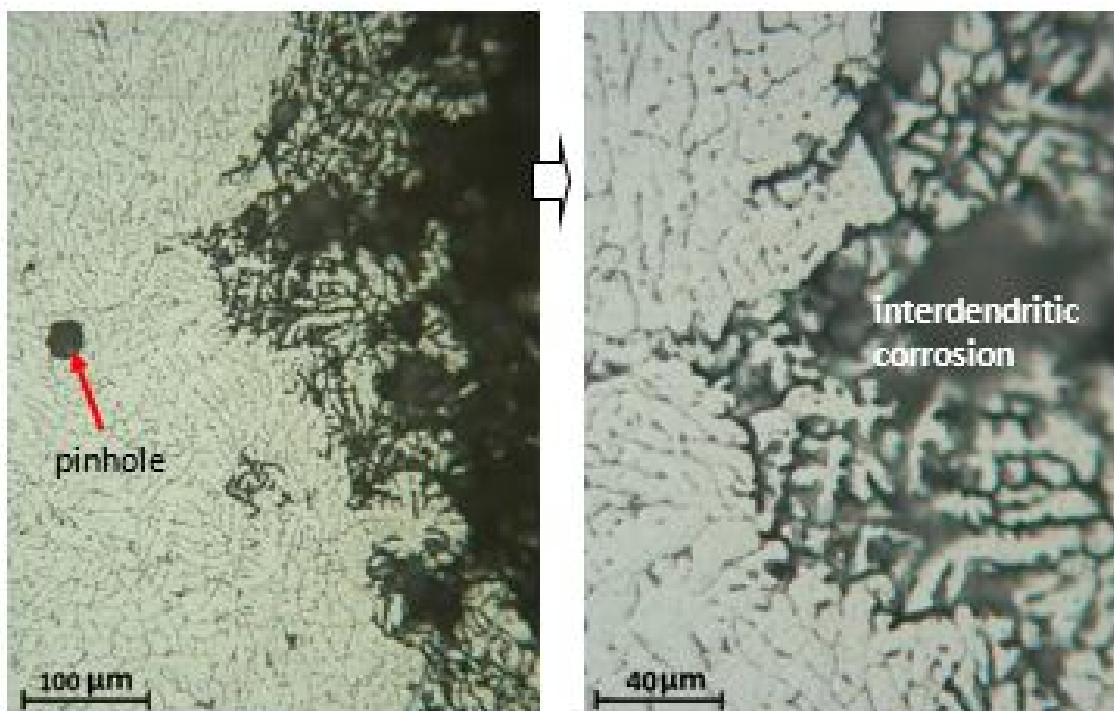
Figure 7b. Microstructure obtained from the weld metal area at header side at location Y as indicated in Figure 6 (etched with Keller solution)

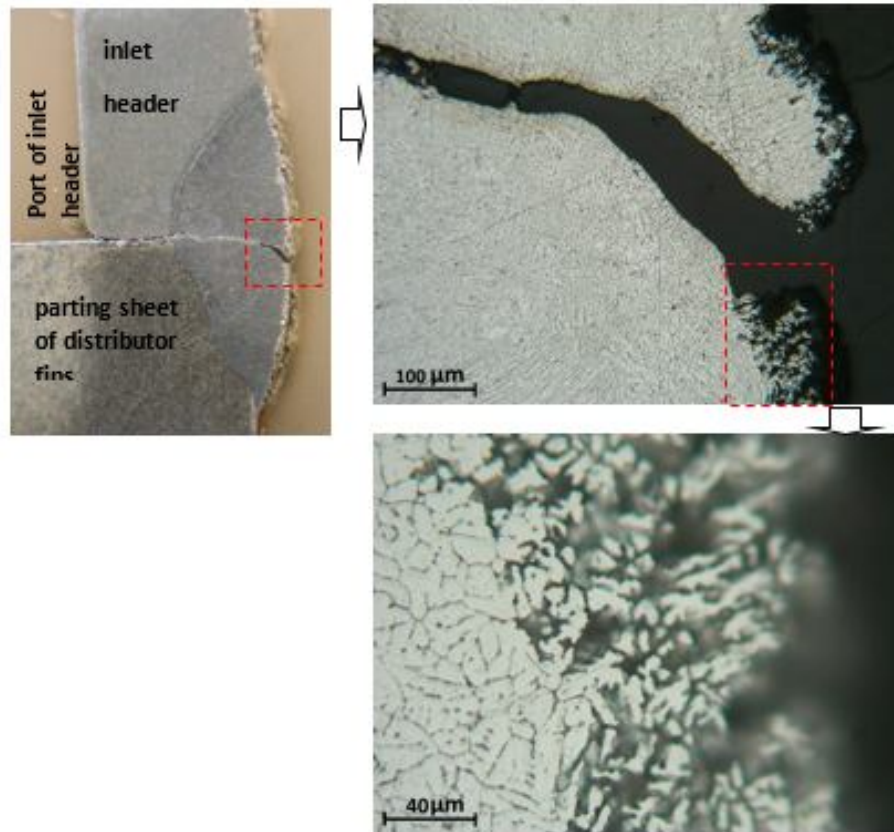
Another specimen for metallographic examination was obtained from the leaked weld joint between the inlet header and the parting sheet of distribution fins (see Figure 8). The microstructures obtained are very much similar with that observed from the previous microstructures shown in Figure 7. The fracture shown in Figure 8 was most likely originated from the corroded weld surface which was heavily

damaged by interdendritic corrosion, and progressed into the internal port of the inlet header through the parting line between the header and the parting sheet of distributor fins. Similarly, the fracture may have also been related with some weld defect (pinholes) that formed in the weld joint between header and the parting sheet.

Figure 8. Microstructure obtained from the weld joint between header and parting sheet of distributor fins at location as indicated (etched with Keller solution)

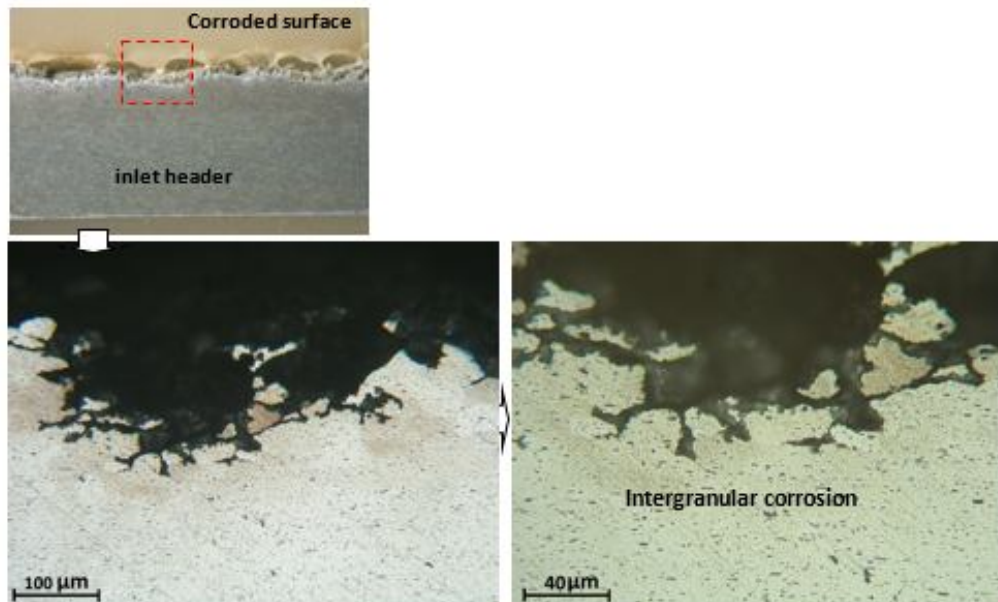
Details of microstructure obtained around the corroded surface area of the inlet header are clearly presented in Figure 9. It is seen that most of the header surface was severely affected by intergranular corrosion. Similarly to the microstructures shown in Figures 7 and 8, this intergranular corrosion was most likely caused by sensitization due to formation of some intermetallic phases at the grain boundaries [1, 2, 8, 10].

Figure 9. Microstructure obtained from the corroded area of the header surface at location as indicated (etched with Keller solution)

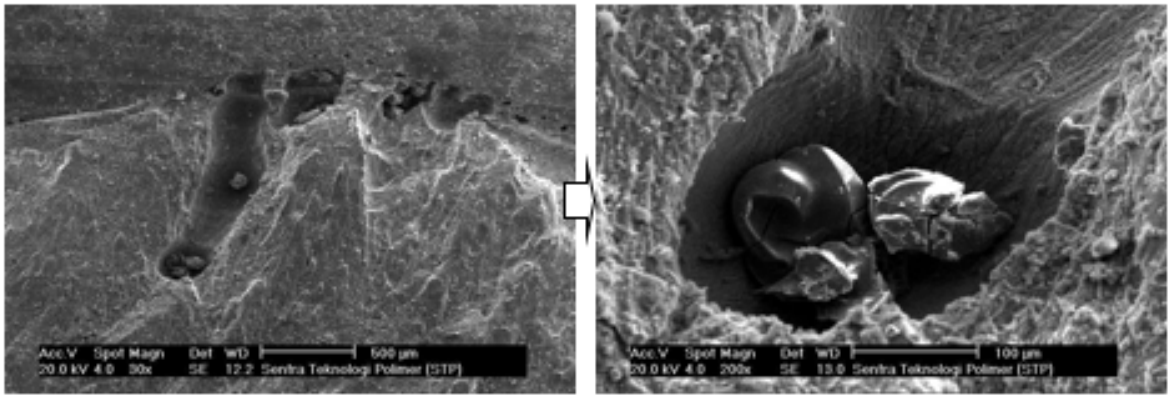
SEM fractographs obtained from surface fracture of the failed after-cooler are presented in Figure 10. The fractographs obtained show the surface fracture of the weld joint between the header and the side bar/parting sheet that apparently contained a number of pinholes. These pinholes in some extent may have contributed to the crack or fracture formation. The crack may have been initiated from the corroded surface of the weld joint and progressed inward to the pinhole area where a high stress concentration may have present. As seen

clearly in Figure 10, one large pinhole was filled with some inclusions.

Figure 10. SEM fractographs of surface fracture obtained from the leak area of the weld joint between the header and the side bar/parting sheet.

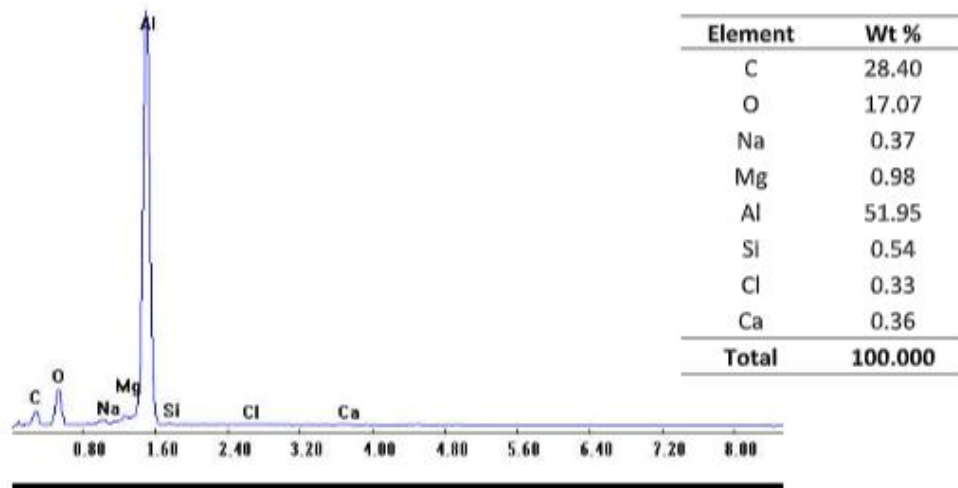
The EDS spectrum obtained from the header surface fracture shown in Figure 10 that experienced corrosion damage shows some major elements such as aluminum (Al), carbon (C) and oxygen (O) (see Figure 11). The oxygen content obtained is much likely affected by the oxide formation due to corrosion (as corrosion product). Whereas the high carbon content found in the EDS spectrum may be influenced by some leakage of hot compressor lubricating oil that entered into the oil cooler. In addition to those elements, there are also other elements observed in the EDS spectrum such as magnesium (Mg), silicon (Si), sodium (Na), chloride (Cl) and calcium (Ca). Both elements of Mg and Si are the alloying elements of the aluminum alloy AA5xxx. The source of Na and Cl was most likely coming from the sea water and/or its moisture contamination, or may be present in other aqueous environment as a contaminant. Figure 12 also shows EDS spectrum of elements representing the corresponding composition of inclusion that formed inside a large pinhole shown in Figure 10. Basically, the inclusion is a typical aluminum oxide that formed from the filler metal during welding.

Figure 11. EDS spectrum of element representing the corresponding composition of the header surface fracture shown in Figure 10.

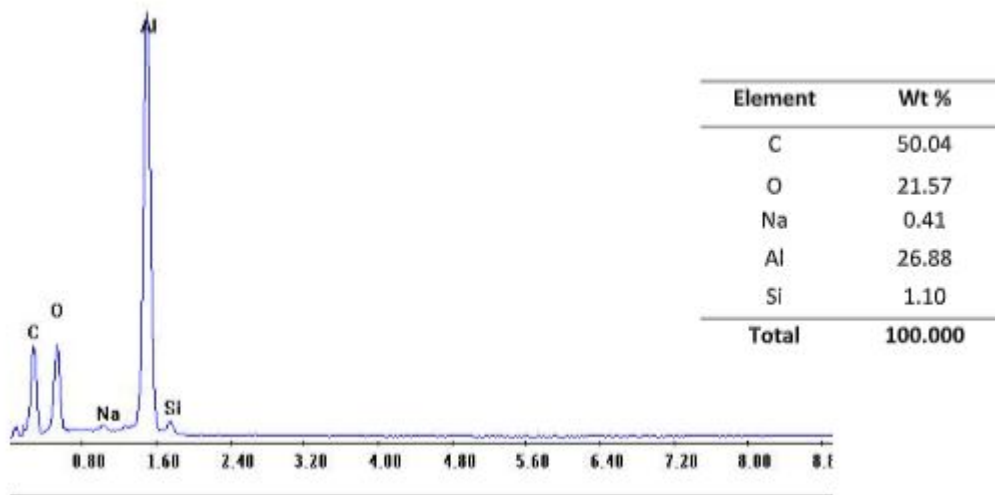
Figure 12. EDS spectrum of elements representing the corresponding composition of inclusion formed inside a pinhole shown in Figure 10

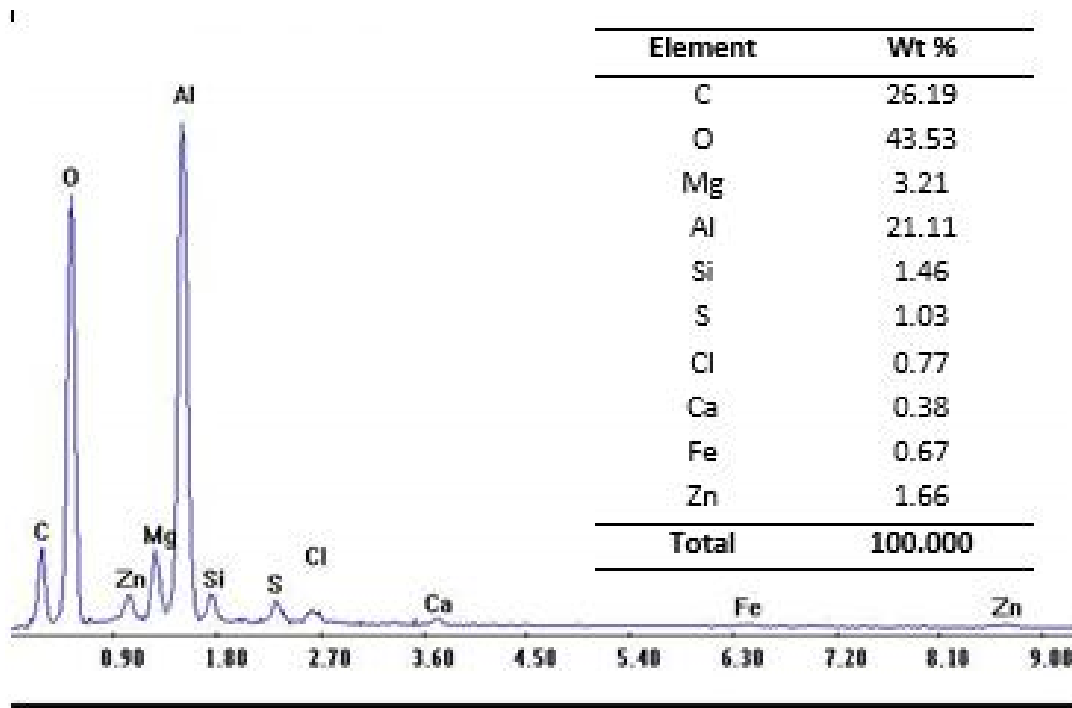
Other result of EDS analysis was also obtained from some corroded surface area located around the edge of the header and close to the weld surface fracture (see Figure 13). Most of the result obtained indicated that oxygen (O) and carbon (C) along with aluminum (Al) and its alloying elements such as Si, Mg, Fe, Zn and some sulfur (S), chloride (Cl) and calcium (Ca) were detected on much of the corroded surface scale/corrosion product.

Figure 13 EDS spectrum of elements representing the corresponding composition of some corroded surface of the header.
